DELAWARE RIVER BASIN  
OLD MILL STREAM  
NEW CASTLE COUNTY  
DELAWARE

# HOOPES DAM DE 00015

## PHASE 1 INSPECTION REPORT NATIONAL DAM SAFETY PROGRAM.

Based upon visual observations and review of the information obtained from the City of Wilmington, Water Division, Edgar M. Hoopes Dam is considered to be in overall fair condition.

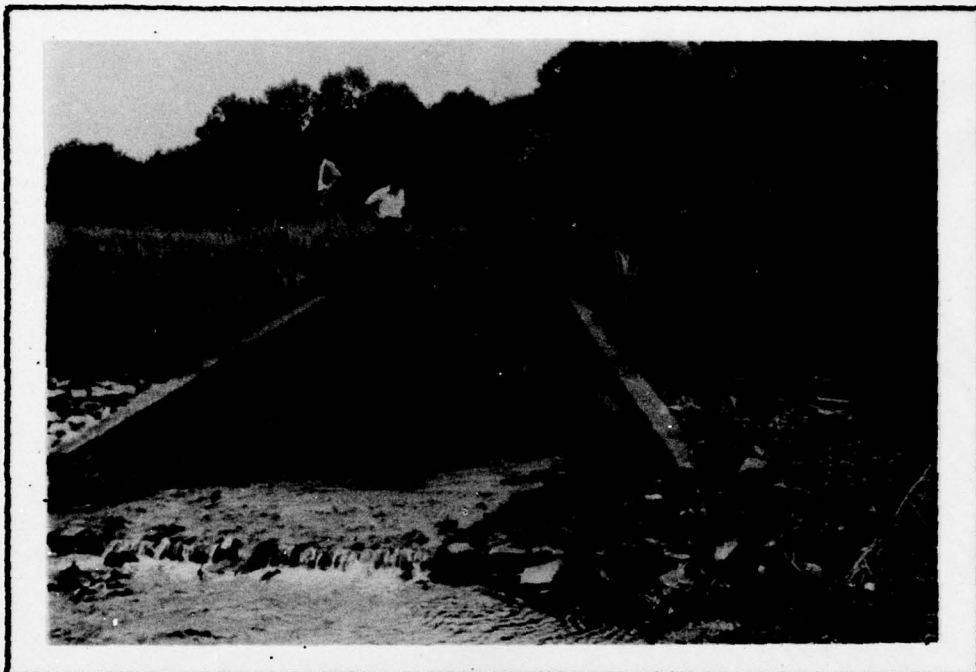
*LEFT DOUBLE-BOX CONCRETE CULVERT BUILT THROUGH  
THE CAUSEWAY CROSSING HOOPES RESERVOIR ABOUT  
TWO MILES UPSTREAM OF THE DAM 5/24/79*

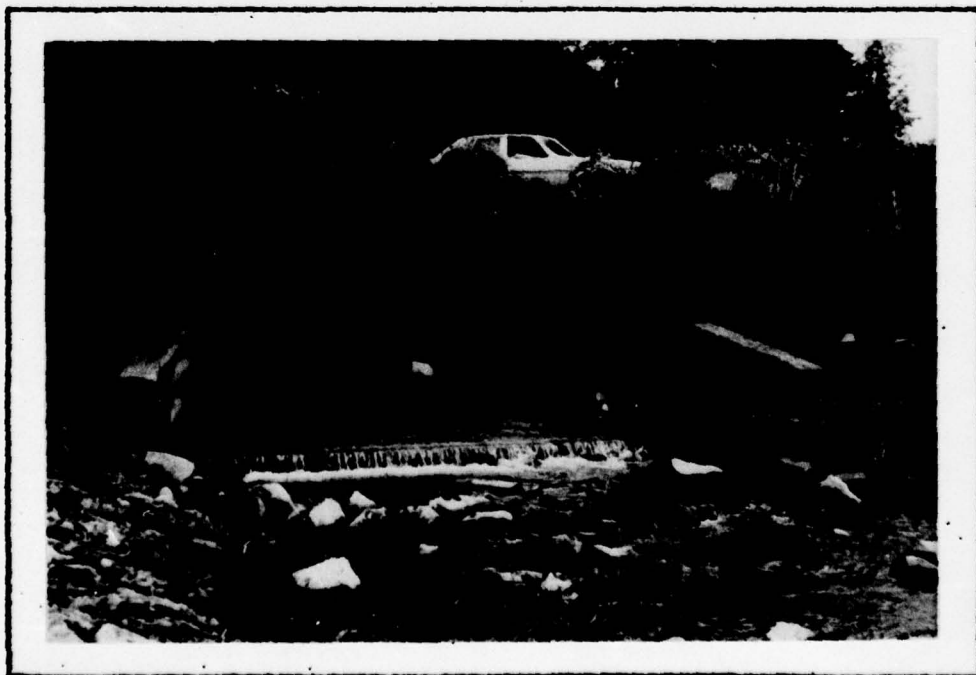
*RIGHT DOUBLE-BOX CONCRETE CULVERT BUILT THROUGH  
THE CAUSEWAY CROSSING HOOPES RESERVOIR ABOUT  
TWO MILES UPSTREAM OF THE DAM 5/24/79*

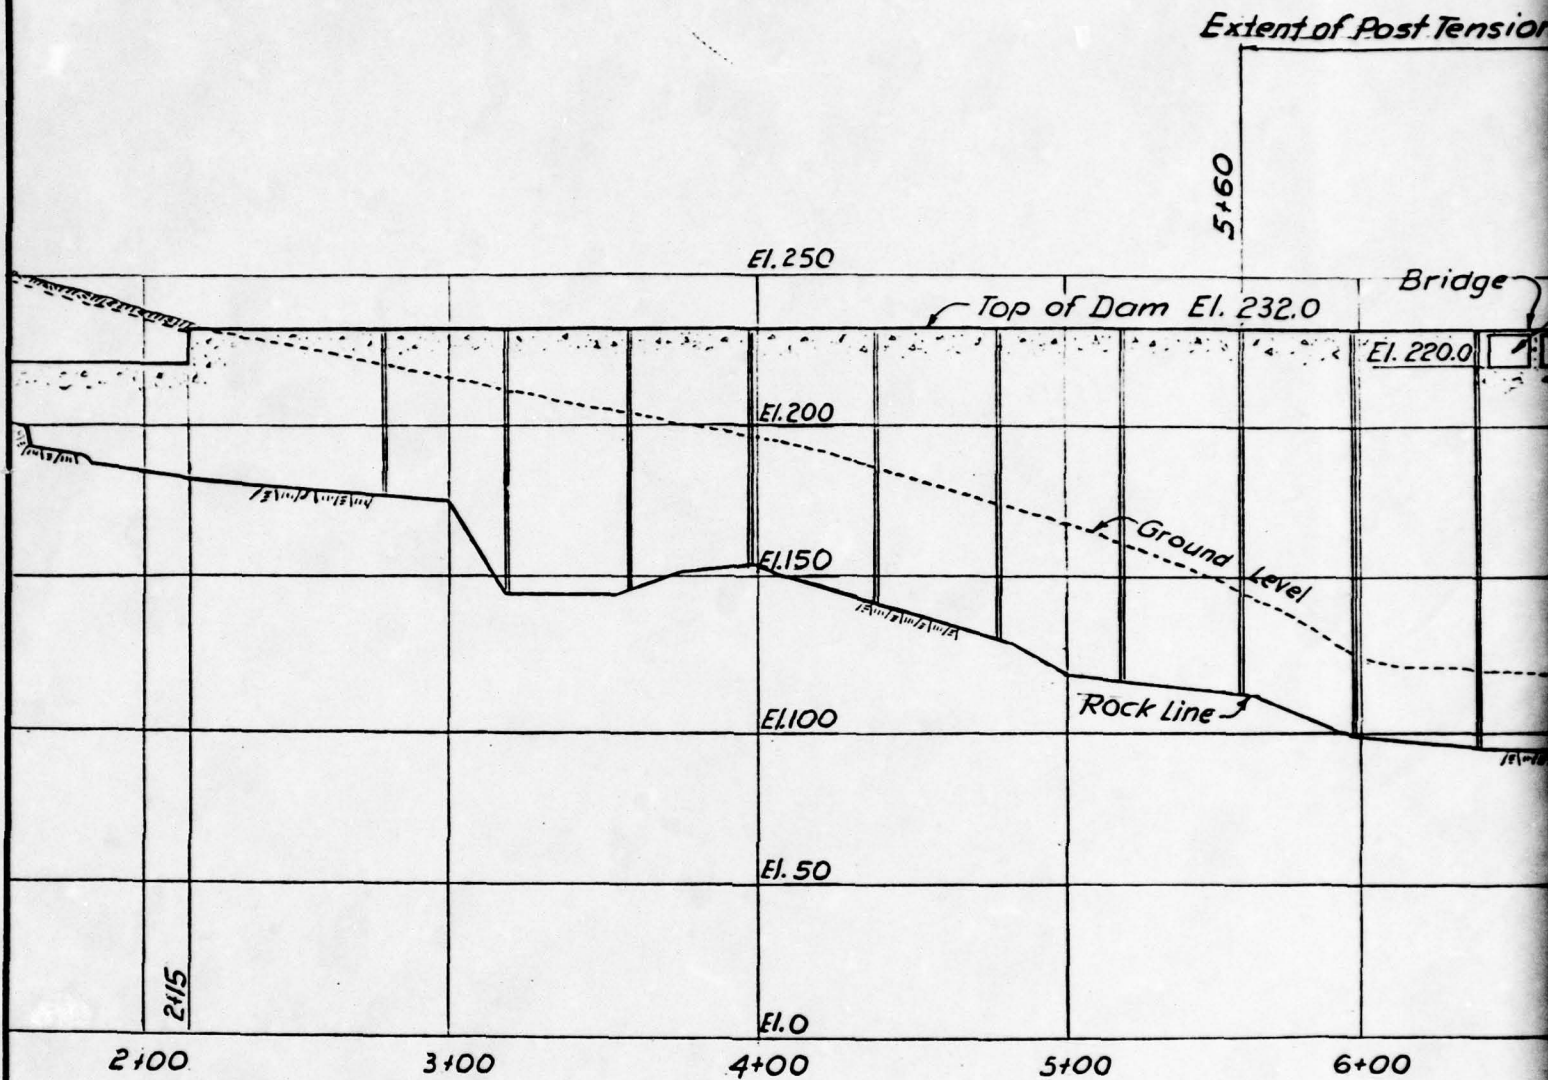
LONGITUDINAL

Post Tensioned Cables Required
